**RE: Request for Information (RFI) Pursuant to Section 308 of the Clean Water Act
Roadway of Oneonta (NYR00C392)
Docket No. CWA-IR-15-016**

COMPLIANCE EVALUATION INSPECTION REPORT

Compliance Evaluation Inspection: Roadway of Oneonta (aka Roadway Auto)
Inspection Date: July 15, 2014 Inspection Time: 11:30 AM – 2:15 PM
EPA Inspector: Katherine Mann, Physical Scientist, USEPA Region 2, DECA, Water Compliance Branch, (212) 637-4226
NYSDEC Representative: Not present
Site Representative: Gwen Stage, Owner, 607-432-0014 (p), 607-432-0053 (f)
Site Information: 139 Timer Road, Oneonta, NY 13820 SPDES No. NYR00C392
Owner/Operator/Permittee: Gwen Stage, Owner Roadway of Oneonta
SIC Code: 5015 (Motor Vehicle Parts, Used) – MSGP Sector M (Automobile Salvage Yards)

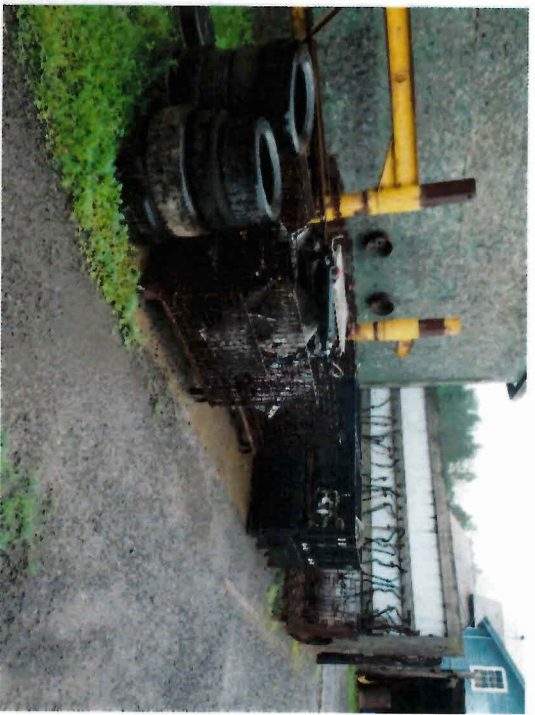
As identified in photographs P7150004 and P7150005, core piles were stored in an area exposed to stormwater at the time of the CEI. It was noted by the EPA inspector during the CEI that the Facility's SWPPP recommends that cores be stored under cover, over concrete, and in secondary containment. Upon returning briefly to the Facility on the morning of July 17, 2015, the EPA inspector noted that the core piles had been covered with tarps (see photograph P7160253).

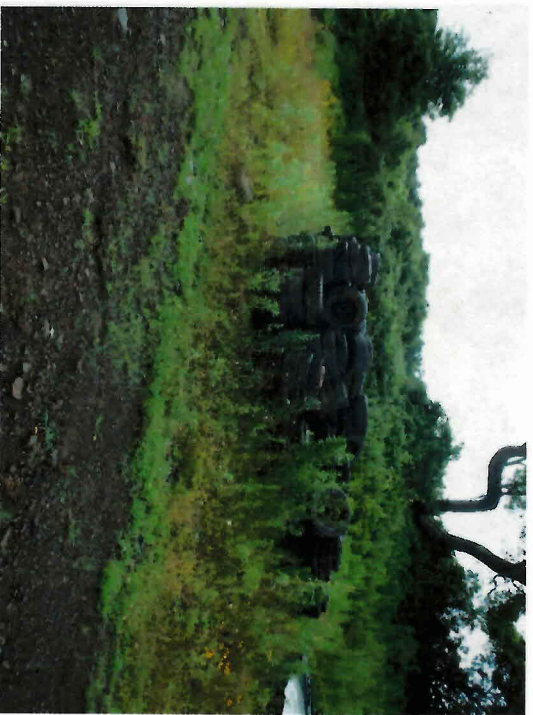
P7150008

4. As identified in photographs P7150008, P7150009 and P7150012, at the time of the CEI, scrap tires were stored on the northeast side of the Site, upstream of outfall 001, in an area exposed to stormwater. While the SWPPP states that the tires are regularly sold to a scrap buyer to control the onsite inventory, the SWPPP does not identify any BMP(s) for minimizing exposure of scrap tires to stormwater.
5. As identified in photographs P7150013, erosion was identified upstream of outfall 001. Ms. Stage stated that sometimes she observes sediment in the visual quarterly monitoring sample. Erosion and sediment controls should be utilized at this location in order to prevent sediment from being discharged from the Site.

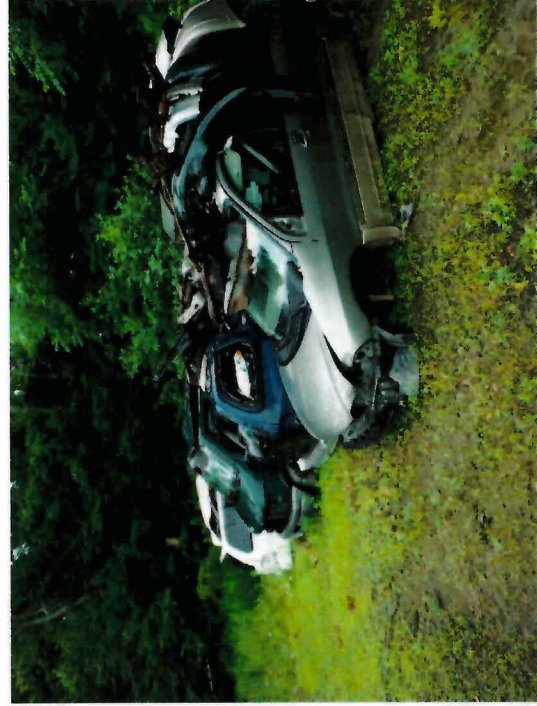
- b. Parts III.C.6.m and III.C.6.n of the Permit require that the Site Map identifies storage areas and potential pollutant sources. The vehicle storage area located northeast of outfall 001 and identified in photograph P7150011 was not identified on the Site Map maintained with the SWPPP at the time of the CEI.

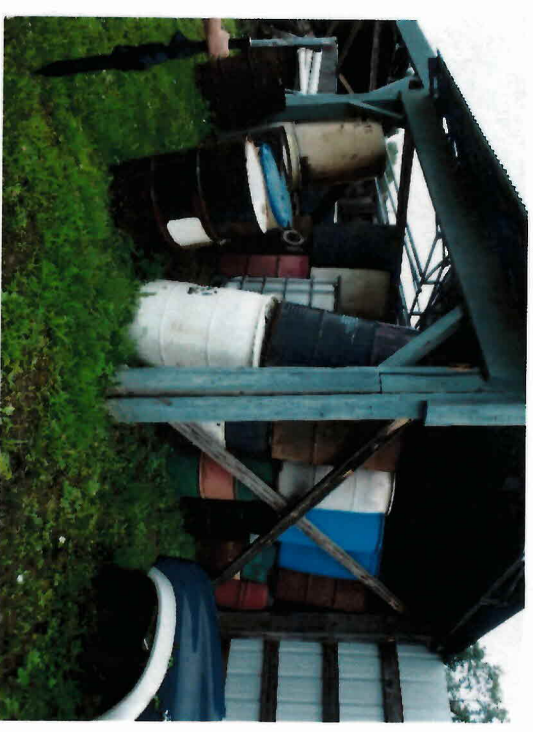
- c. The SWPPP states that fluids should be stored either inside or outside under cover. The SWPPP also states to ensure all fluid containers are clearly labeled and secondary containment is provided. As identified in photographs P7150020 and P7150021, approximately five (5) 55-gallon drums were not stored completely under cover on the southwest side of the Site. Secondary containment for fluid storage containers was not utilized at the Facility at the time of the CEI.

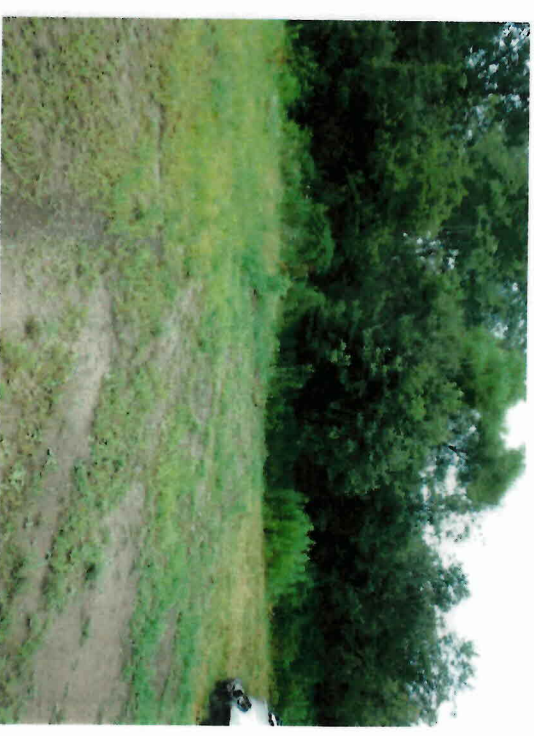
P7150022

1. In accordance with Part III.A of the Permit, a SWPPP shall be developed and implemented by the owner or operator for each facility covered by the Permit. At a minimum, the SWPPP is required to include the items identified in Part III.C and Part VIII (Sector-Specific Requirements, Sector M, pages 120 – 125) of the Permit. Based on review of the SWPPP available at the time of the CEI, as well as observations made during records review and the Facility walk-through, the Facility failed to develop and/or implement the following SWPPP elements, as required by Part III.A of the Permit:
 - a. Parts III.C.6.c and III.C.6.d of the Permit require that the Site Map identifies the location of each outfall labeled with the outfall identification, as well as the approximate outline of the drainage area to each outfall. As identified in photographs P7160254 – P7160257

and P7150022, an eroded flow path identified down the center of the Site that terminates at the edge of the wetland north of the Site suggested that there may be an additional, third outfall located between existing outfalls 001 and 002. If stormwater leaves the Site at this location, the outfall must be identified in a revised SWPPP, and a Notice of Modification ("NOM") including the additional outfall must be submitted to the NYSDEC, in accordance with Part I.F.3 of the Permit.
